**DEPARTMENT OF TRANSPORTATION**

Contract #: 04-0120F4Cty: SF/ALA Rte: 80 PM: 13.2/13.9File #: 69.28**WELDING INSPECTION REPORT****Resident Engineer:**Siegenthaler, Peter**Address:** 333 Burma Road**City:** Oakland, CA 94607**Report No:** WIR-023262**Date Inspected:** 04-May-2011**Project Name:** SAS Superstructure**OSM Arrival Time:** 700**Prime Contractor:** American Bridge/Fluor Enterprises, a JV**OSM Departure Time:** 1900**Contractor:** Zhenhua Port Machinery Company, Ltd (ZPMC), Changxing Island **Location:** Shanghai, China**CWI Name:** Liu Hua Jie**CWI Present:** Yes No**Inspected CWI report:** Yes No N/A**Rod Oven in Use:** Yes No N/A**Electrode to specification:** Yes No N/A**Weld Procedures Followed:** Yes No N/A**Qualified Welders:** Yes No N/A**Verified Joint Fit-up:** Yes No N/A**Approved Drawings:** Yes No N/A**Approved WPS:** Yes No N/A**Delayed / Cancelled:** Yes No N/A**Bridge No:** 34-0006**Component:** Orthotropic Box Girder( OBG)**Summary of Items Observed:**

## WELDING INSPECTION REPORT

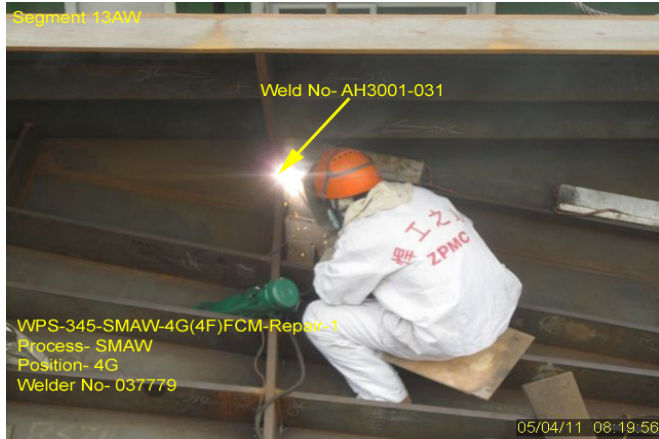
This QA Inspector observed ZPMC qualified welding personnel identified as 037779 perform Shielded Metal Arc Welding (SMAW), weld joint identified as AH3001-031; located On Orthotropic Box Girder (OBG) Side Plate to X419020 CJP Weld; ZPMC Quality Control (QC) is identified as Mr. Shen Jian Bo. This QA Inspector observed the base material appears to have been preheated by an electrical heating element prior to welding. The Welding Repair Report (WRR) was B-WR20812. ZPMC Quality Control (QC) Mr. Shen Jian Bo was onsite monitoring the welding variables. The welding variables recorded by QC appeared to comply with applicable WPS-345-SMAW 4G (4F)

FCM-Repair-1. See attached photo for further details.

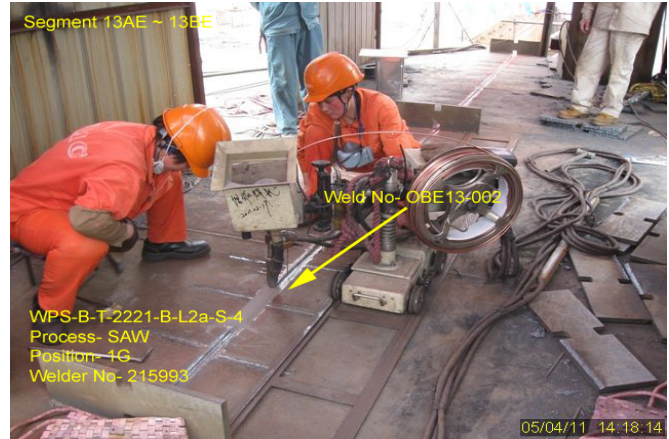
This QA Inspector observed ZPMC qualified welding personnel identified as 066179 perform Submerge Arc Welding (SAW), weld joint identified as OBE13-002; located On Orthotropic Box Girder (OBG) Deck Plate to Deck Plate CJP Weld; ZPMC Quality Control (QC) is identified as Mr. Wang Li Yang. This QA Inspector observed the base material appears to have been preheated by an electrical heating element prior to welding. ZPMC Quality Control (QC) Mr. Wang Li Yang was onsite monitoring the welding variables. The welding variables recorded by QC appeared to comply with applicable WPS-B-T-2221-B-L2a-S-4. See attached photo for

further details.
